**GPHS-RTG SYSTEM EXPLOSION TEST
DIRECT COURSE EXPERIMENT 5000**

1 MARCH 1984

DEPARTMENT OF ENERGY
CONTRACT NO. DE-AC01-79ET-32043

ADVANCED ENERGY PROGRAMS DEPARTMENT

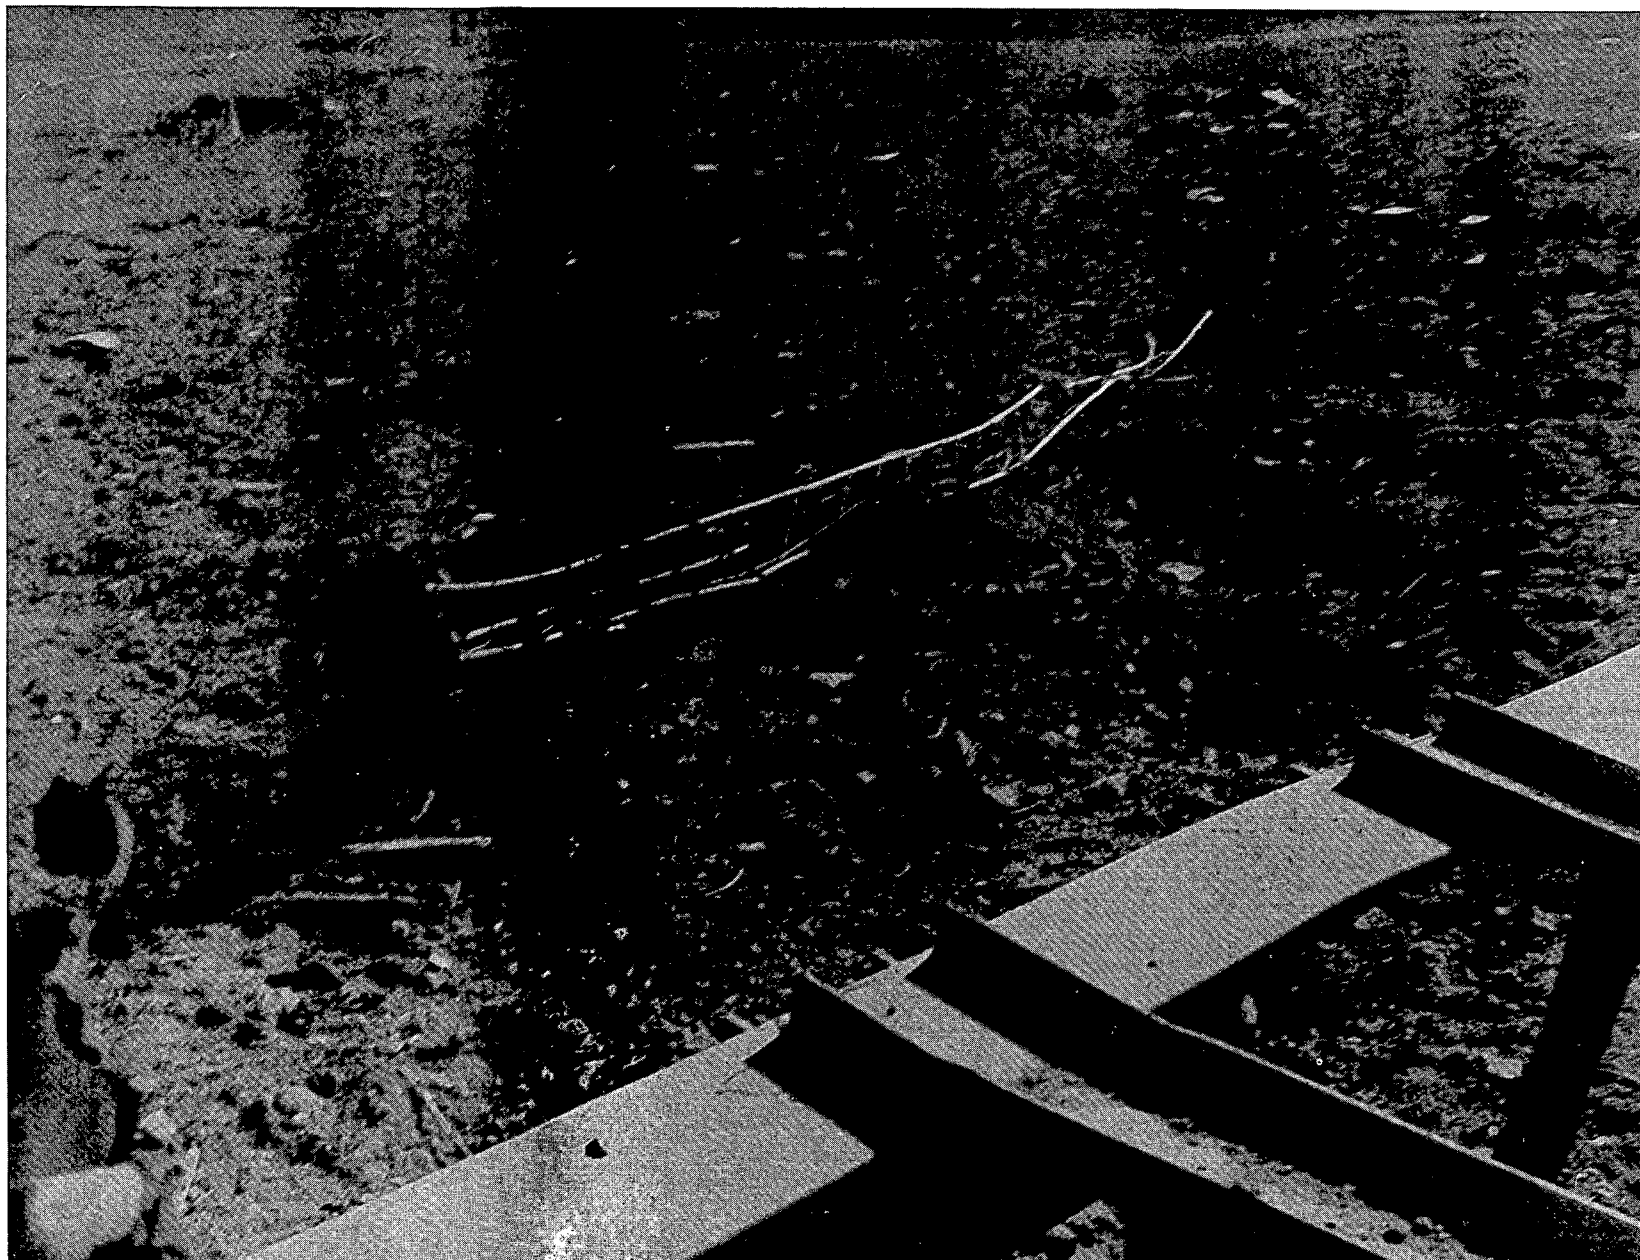
The physical effects of the overpressure and fireball from the 609 tons of ANFO are shown in Figures 27 through 31. The bottom 35 feet of the tower can be seen. Beyond that only a small, occasional piece was found. Figures 30 and 31 show the Nuclear Emergency Search Team (NEST) from Los Alamos National Laboratory (LANL) recovering the radioactive material.

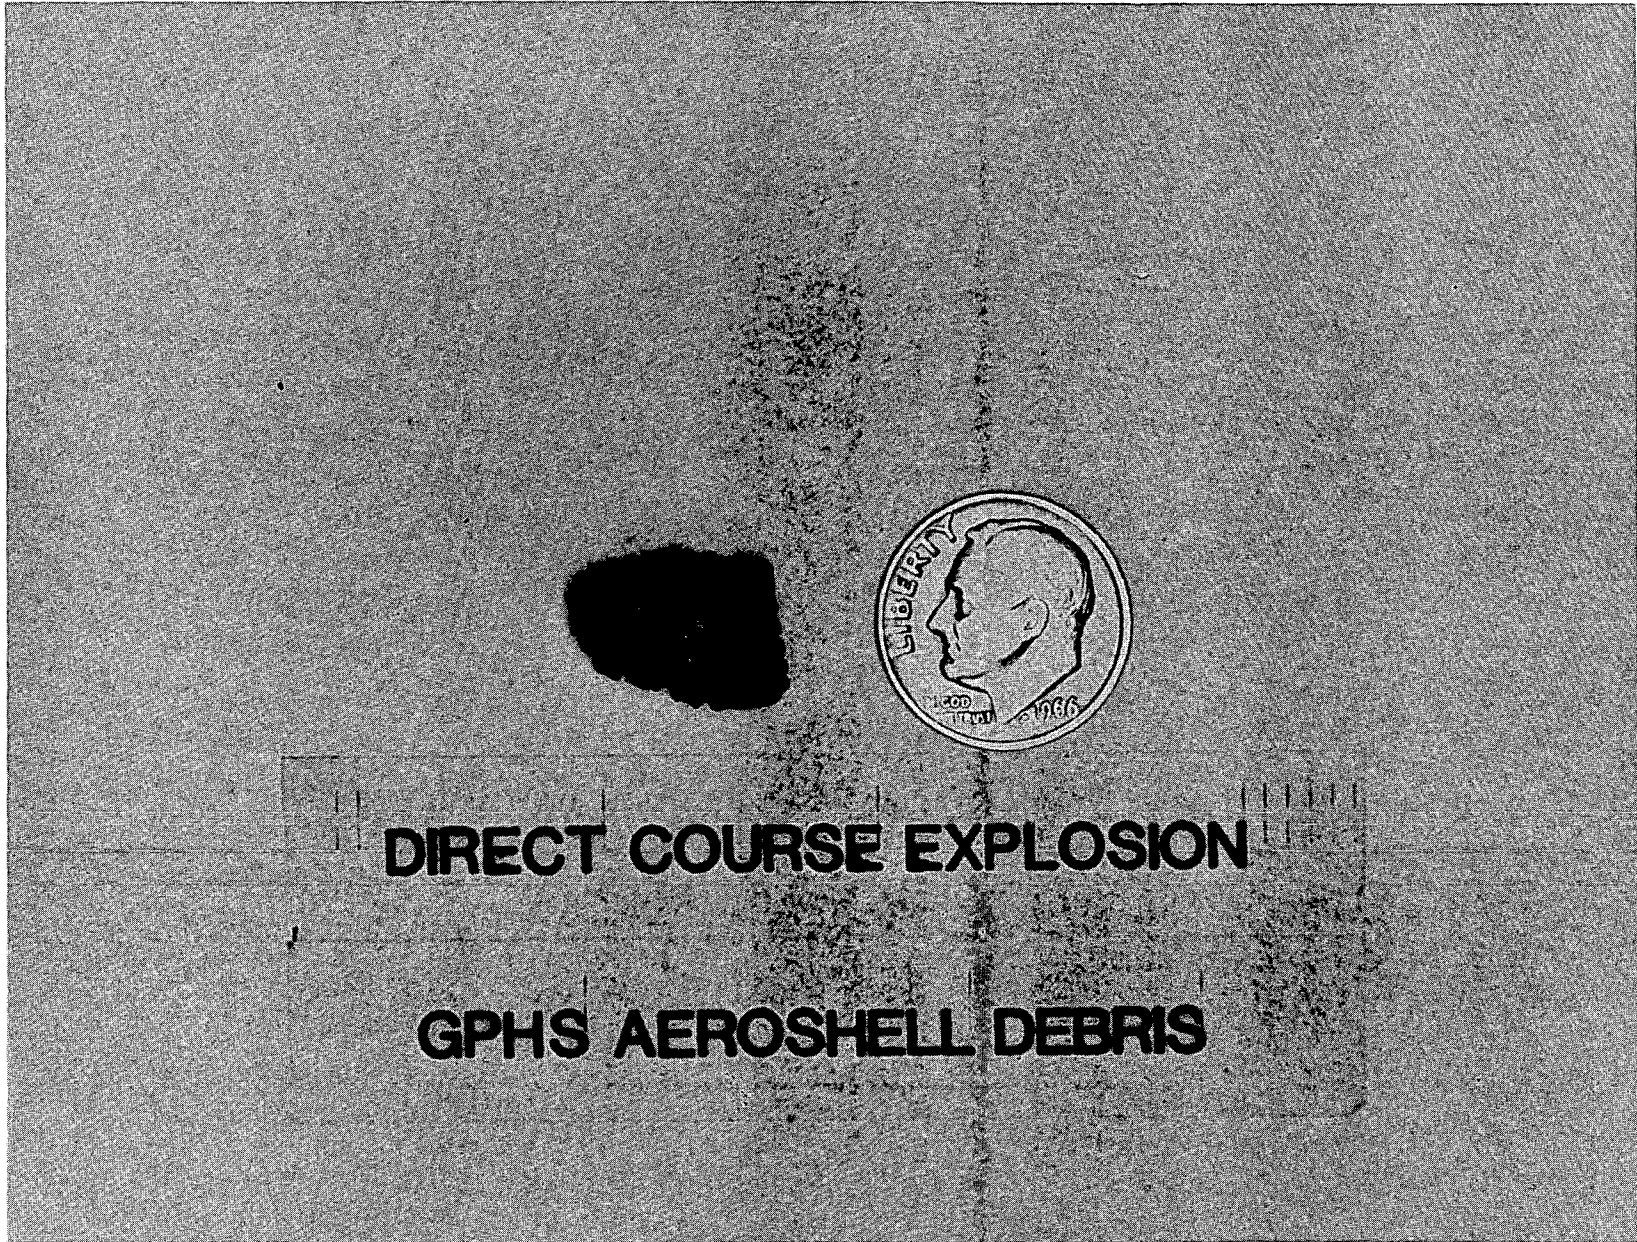
Figure 32. Iridium Fragments Recovered (70% of Total)

About 70% of the iridium from the four clads was recovered and is shown in Figure 32. Figure 33 shows the only piece of graphite recovered; this piece came from the GPHS aeroshell and may be from either the GPHS test article or one of the housings for the electric heaters.

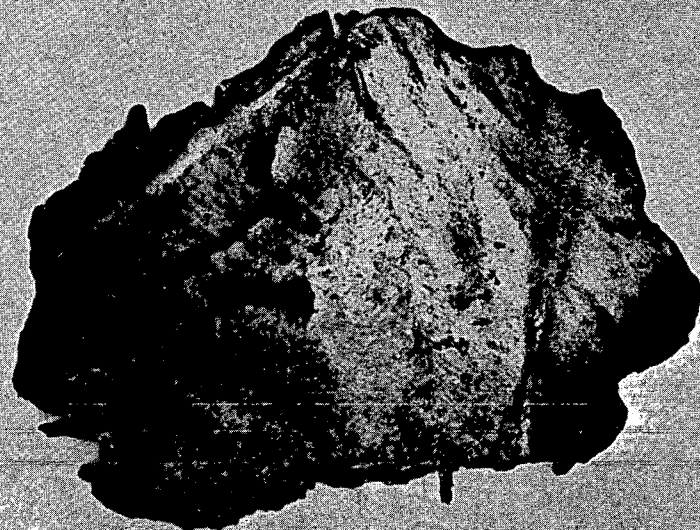
Figure 48. Iridium Fragment #2

Another fragment is shown in Figures 48 and 49 identified as #2. Metallographic sections through this fragment are shown in Figures 50 through 53. Note the necking and the extremely elongated grains plus possible fibrous structure exhibited by the section shown in Figure 52. This evidence indicates that extreme working of the clad occurred which had to result from severe impulsive loading such as by impact from another object at very high velocity or by extremely high pressure. Figure 53 shows another section through fragment #2 that exhibits local coining which also substantiates extreme loading of the metal, probably resulting from impact by another object.
